## **LANGENBURG POWER GENERATION**

### **TECHNOLOGY TEST**

#### **INTRODUCTION**

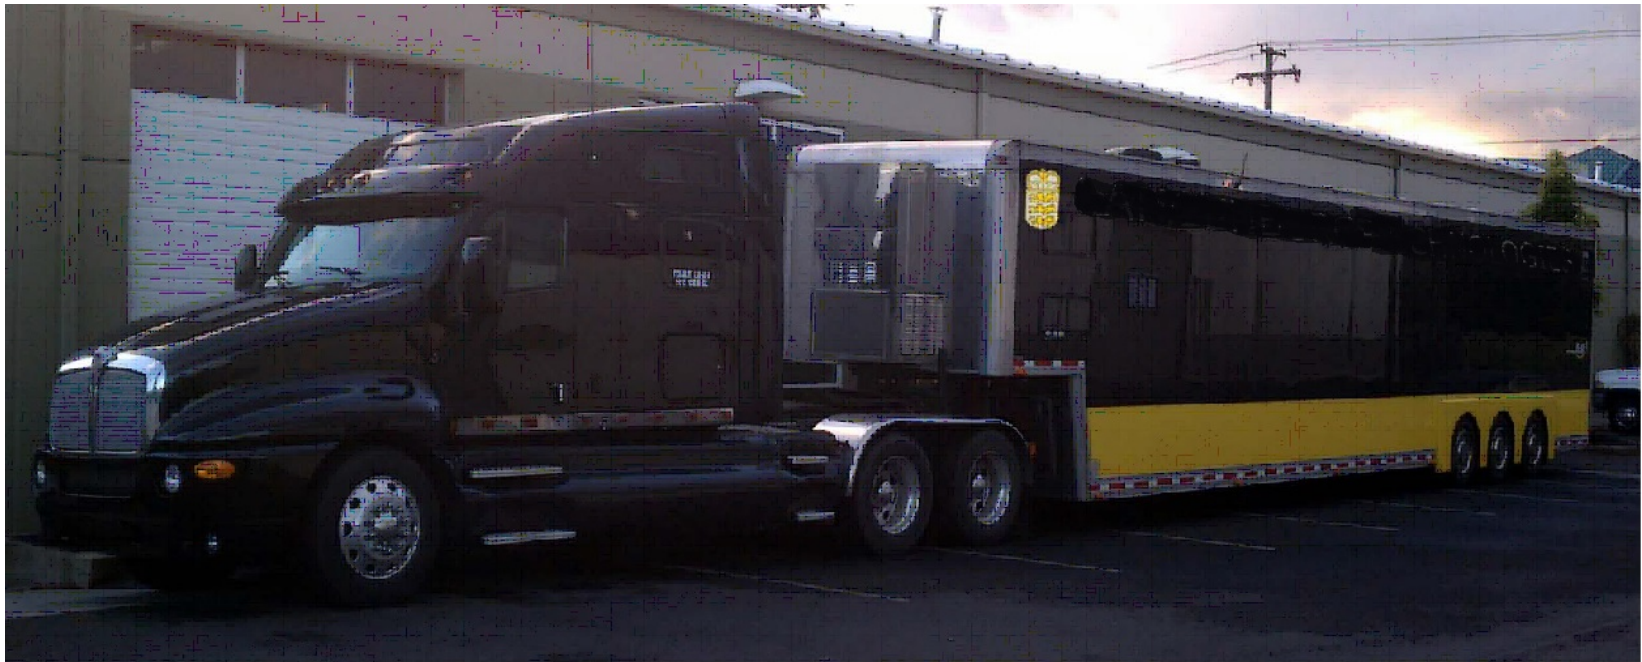
**A-1**

The Langenburg portable water processing and electrical generating system was tested. Photographs of the testing are shown in Attachment A. The Langenburg system is shown in A-1 through A-3, and is claimed capable of purifying 250,000 gallons of water per day and generating 1.1 mega-Watts of electrical power from water.

Langenburg portable water-power system with syn-gas generator

1. Determine the electric generating capacity of the Langenburg system shown in A-1 through A-3.
2. Ascertain the ability of the system to respond to electrical demand within the range of capabilities claimed for the system.
3. Validate the claim that the only input to the system is water.

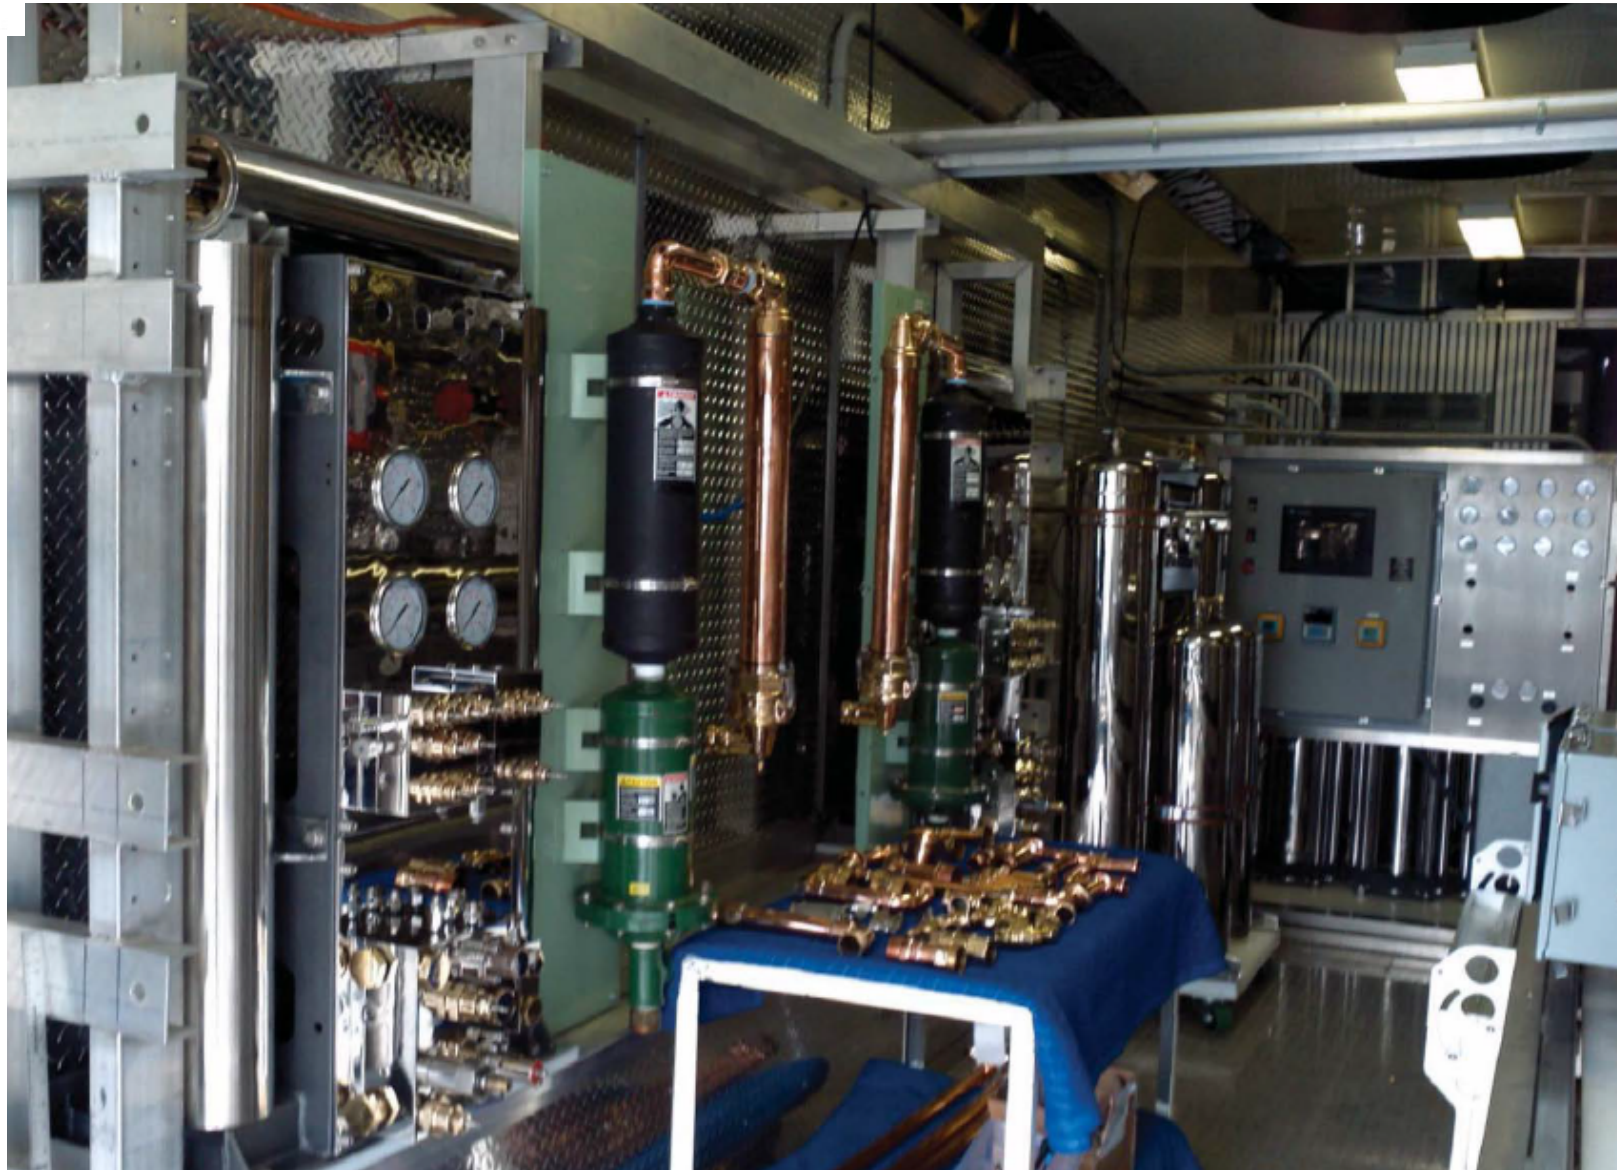
A-2

Inside water-power system

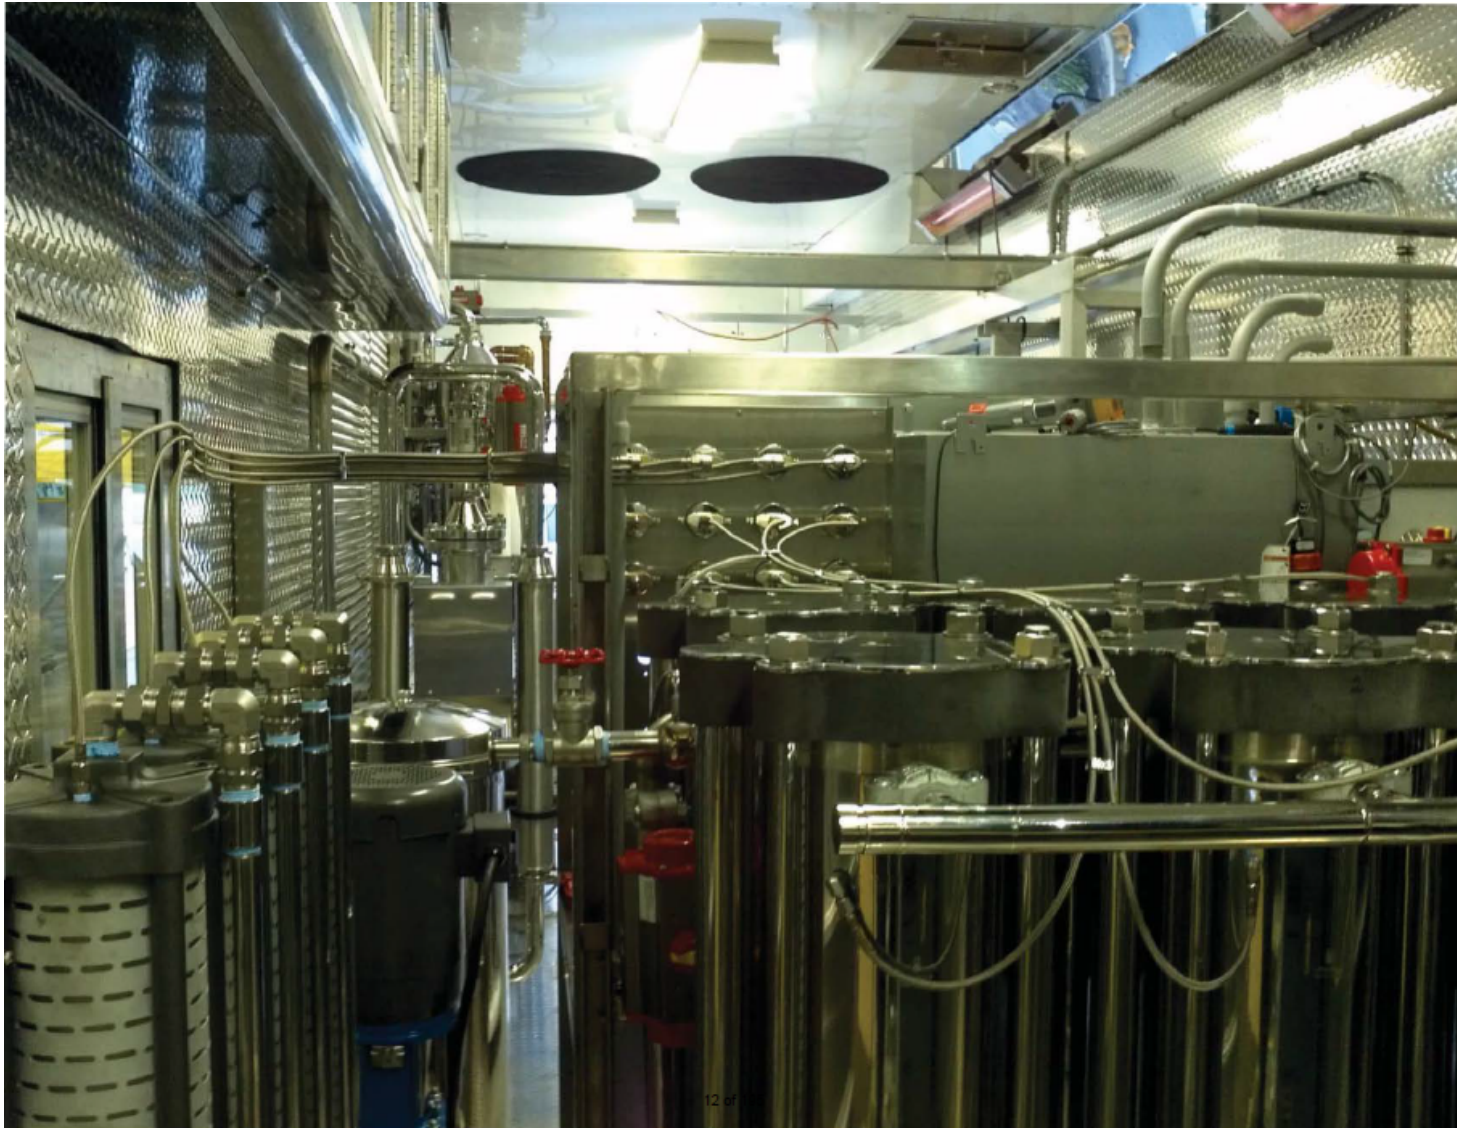
A-3

Inside water-power system

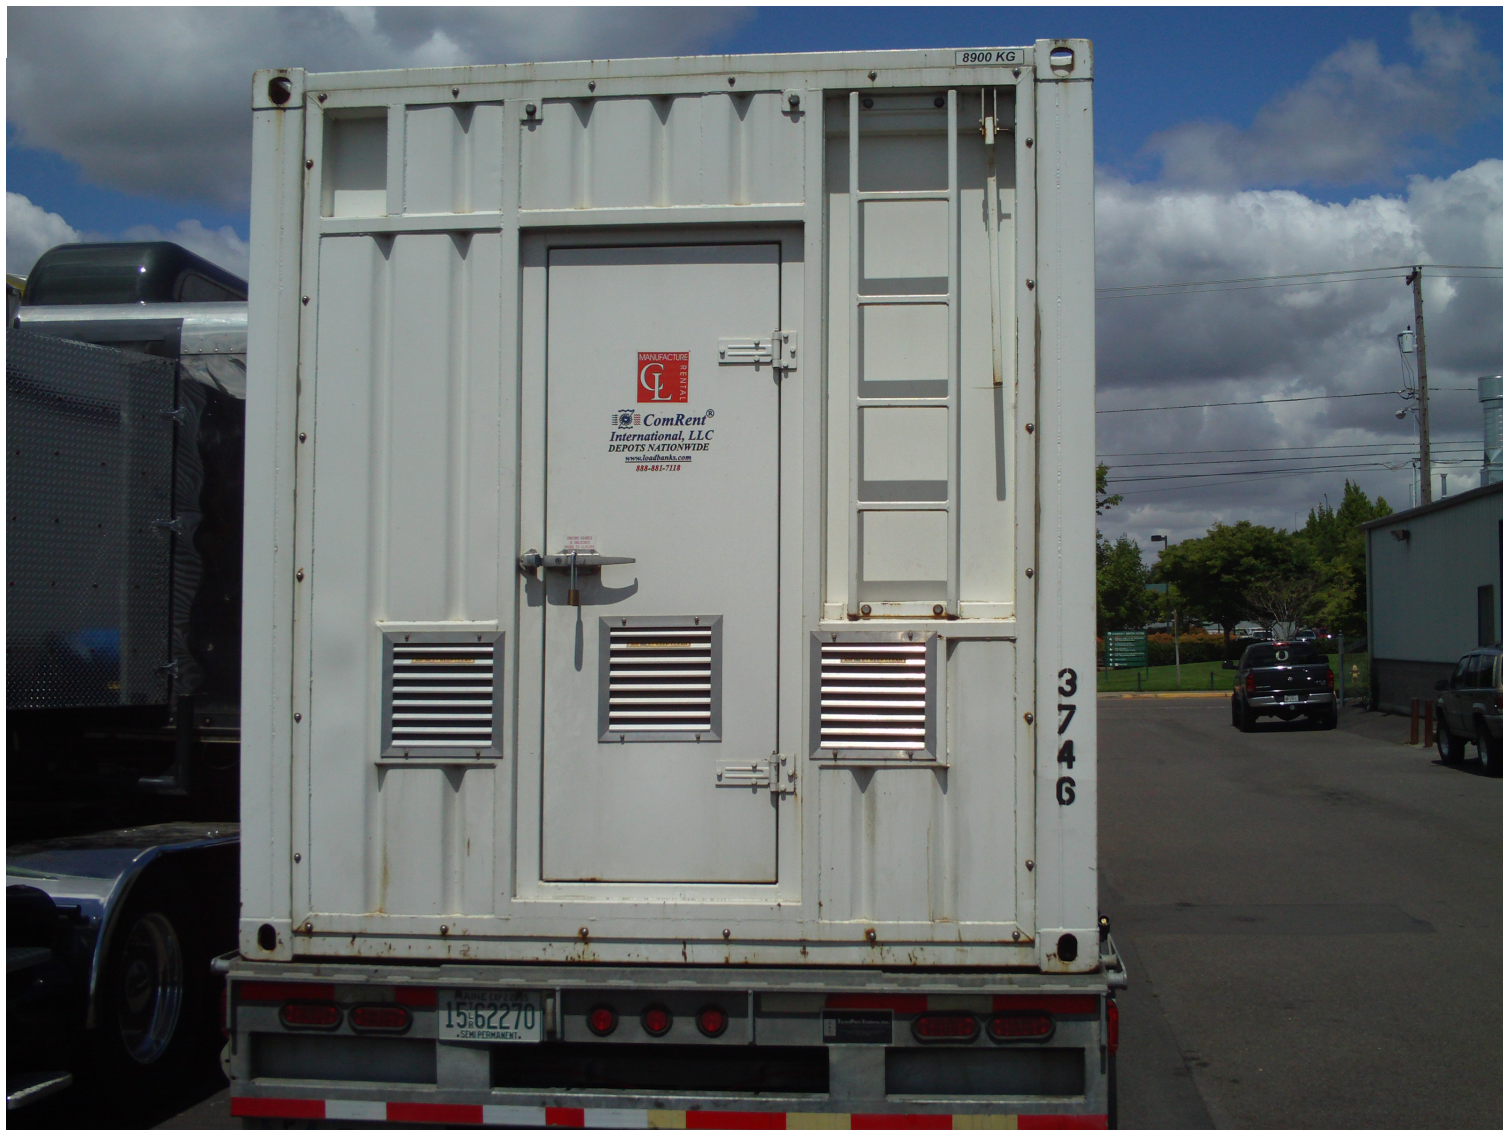
ComRent load-bank

Test equipment included a load-bank provided under contract from ComRent of Kent, Washington. (For more information on ComRent refer to C-1 through C-3- mainly marketing materials. Also see [www.ComRent.com](http://www.ComRent.com)) The ComRent load-bank is shown in A-5 through A-7, and in A-7 is shown electrically connected to the Langenburg generator.

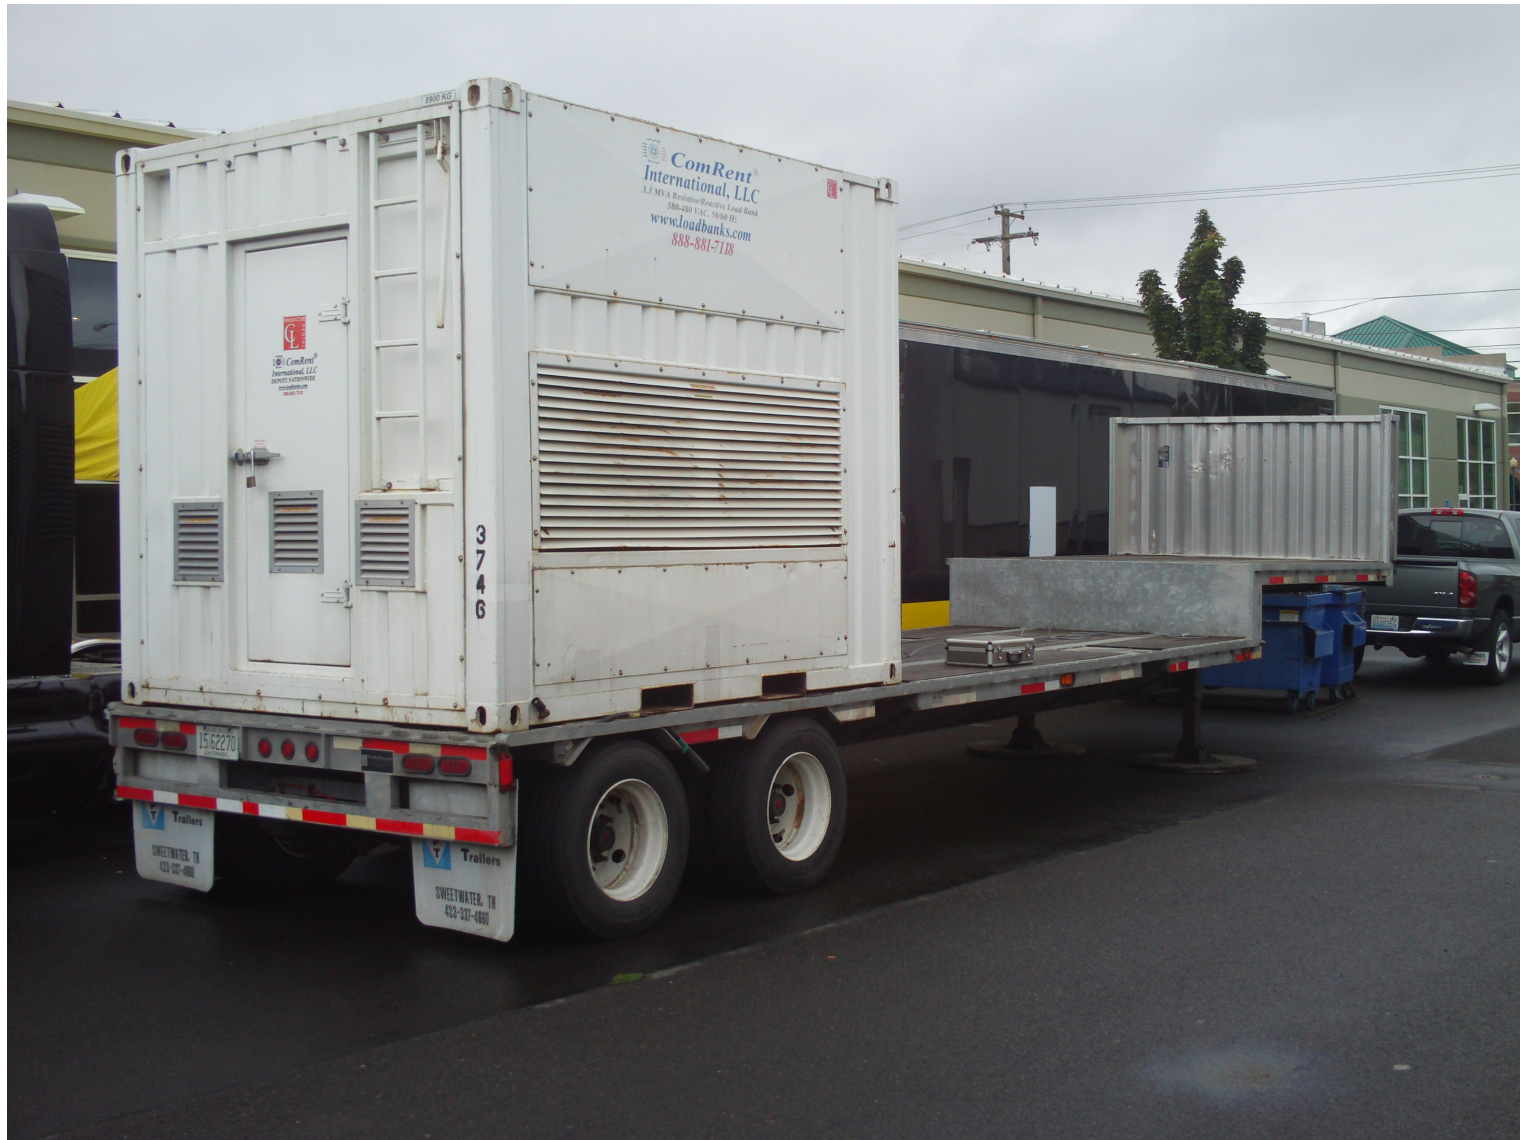
A-6

ComRent load-bank

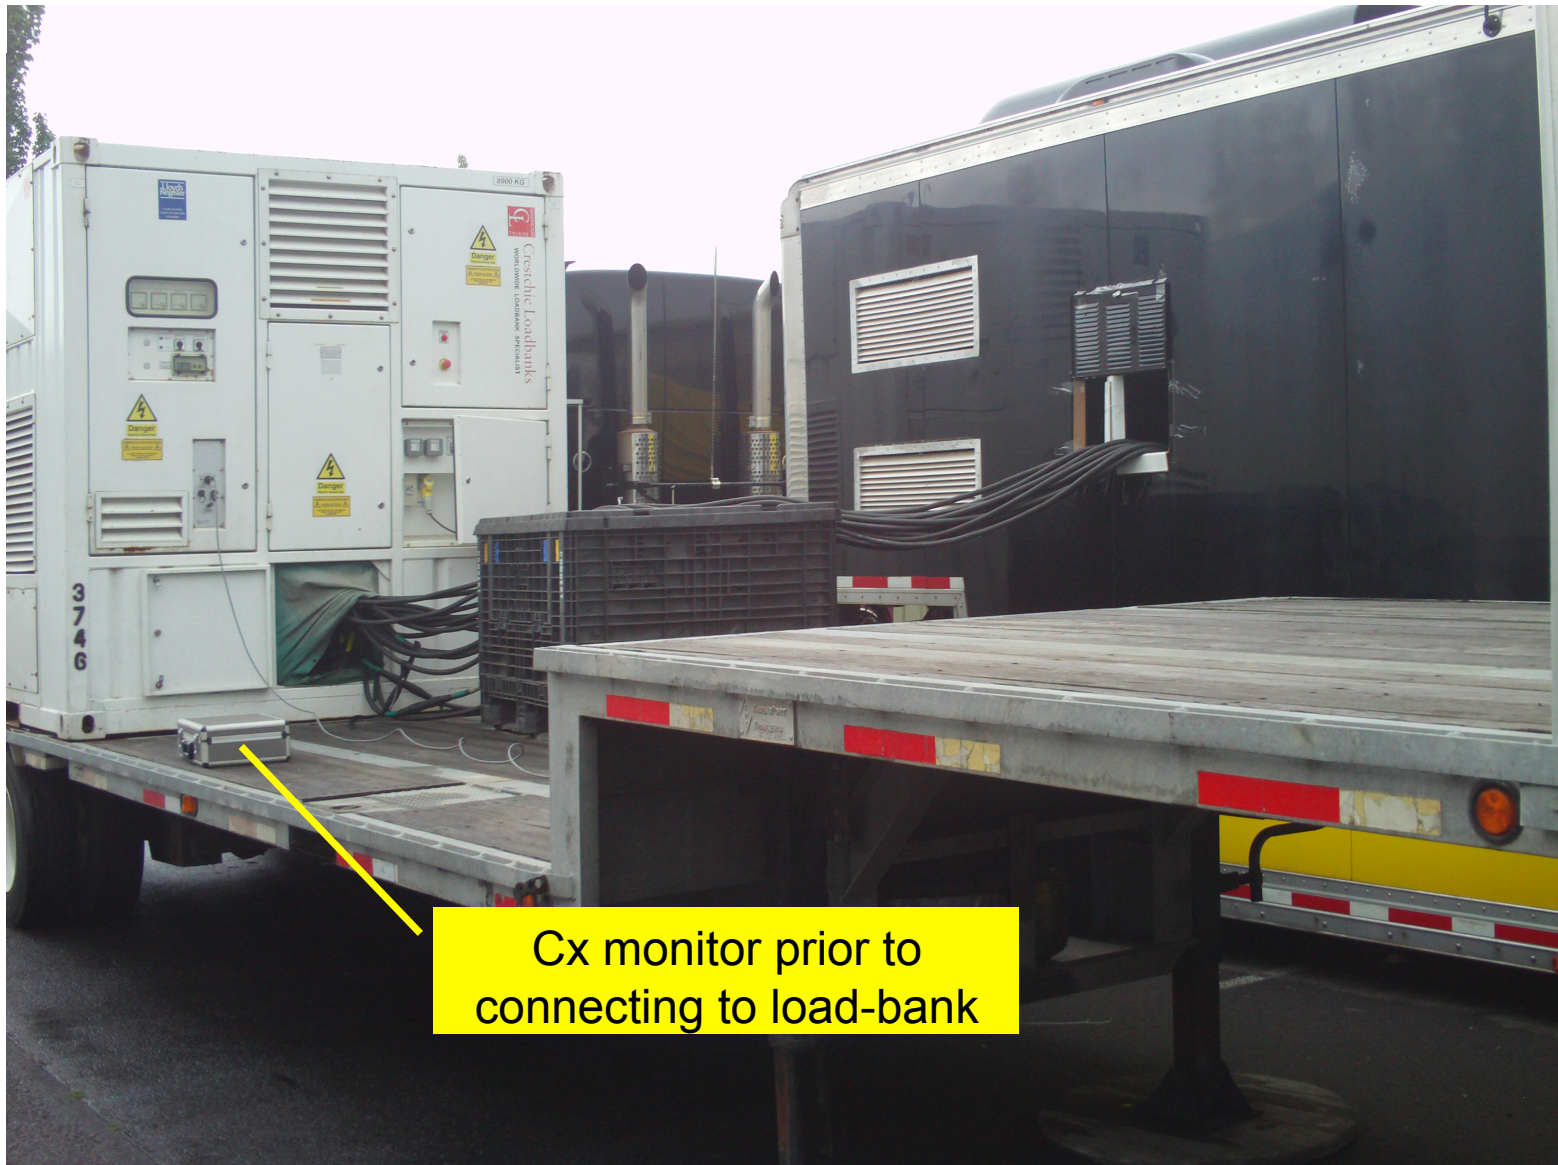
A-7

Cx monitor prior to  
connecting to load-bank

Connecting load-bank to syn-gas powered generator

The Cx monitor is connected directly to the load-bank and is shown in A-7. Specifications for the Cx monitor are found in C-3.

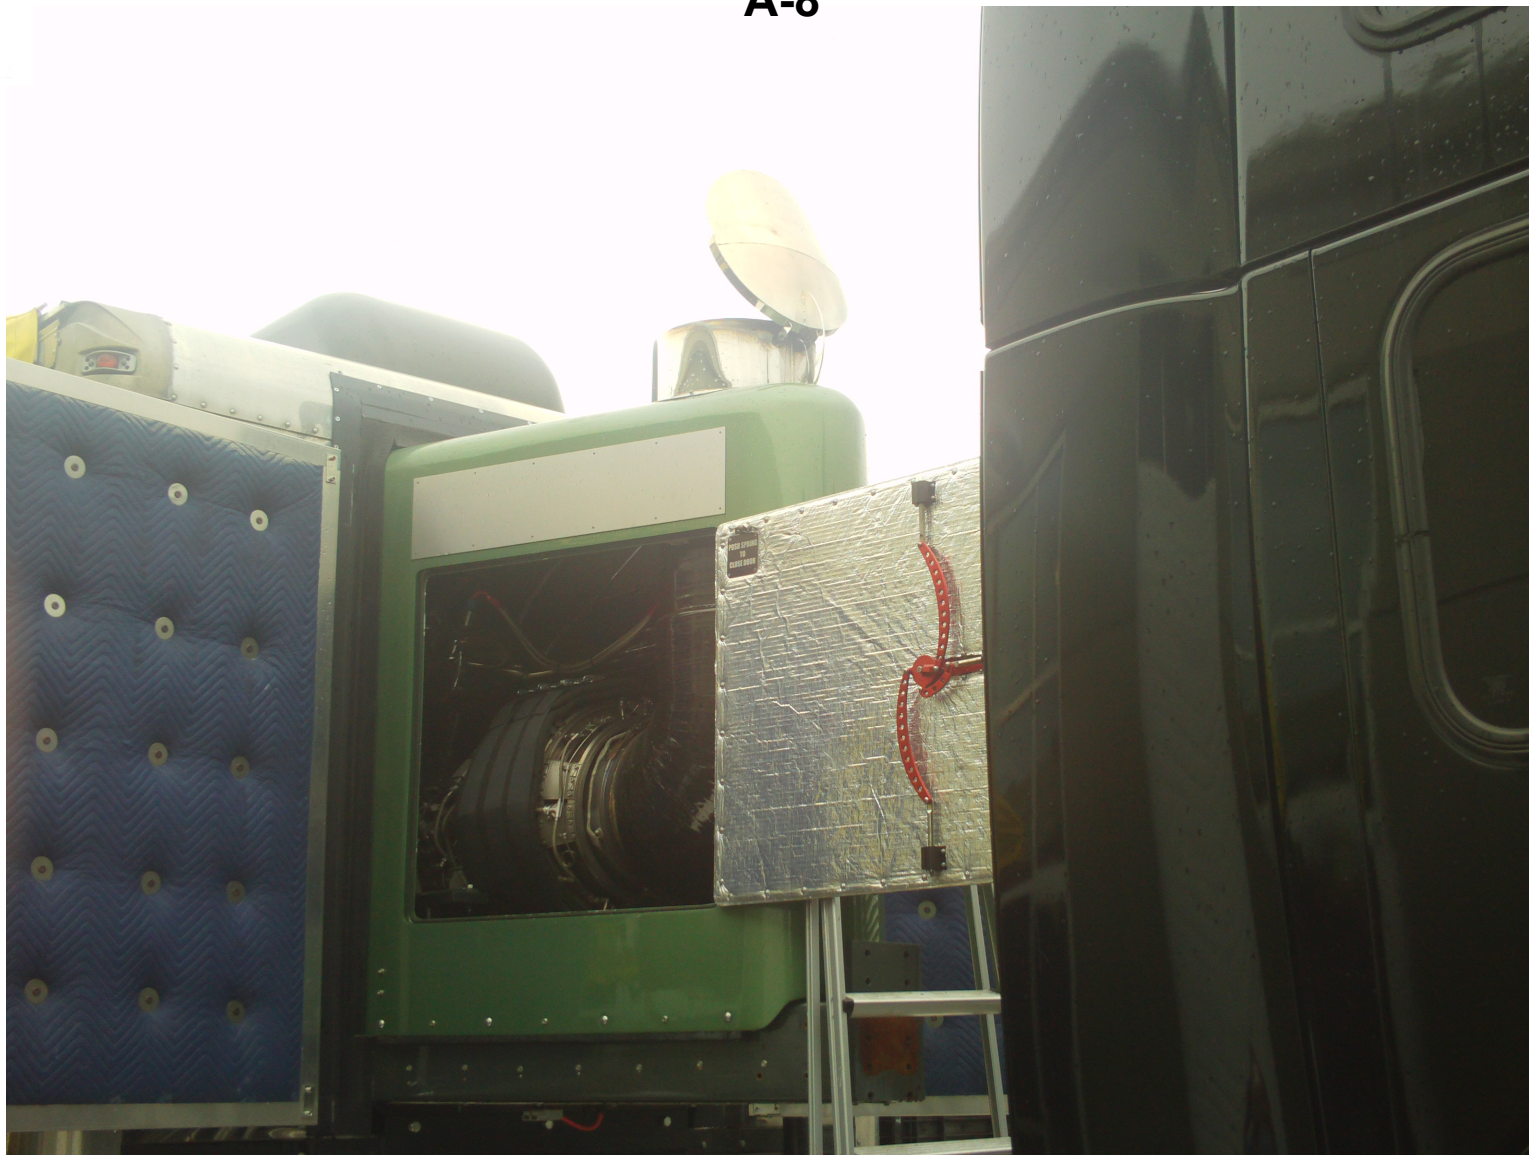
A-8

Syn-gas turbine and exhaust stack for expelling steam formed from syn-gas burn

A-7 shows the Langenburg turbine powered by syn-gas produced from water input. The turbine provides motive power to a generator (not shown), with water (steam) exhausting through a stack also shown in A-7,
